Results of the Lake Minnetonka Nautical Archaeology 3 Project

Hopper Barge Wrecks, 21-HE-441 (Anomalies 453 and 454)

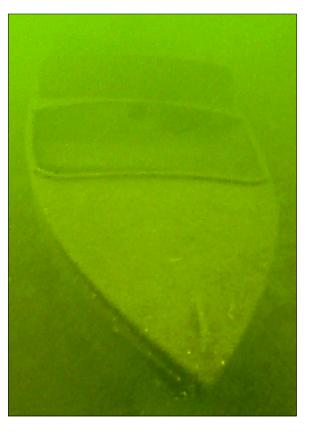
The Alumacraft Center Console Model R Runabout Wreck as seen from the bow. Note the intact windshield (by Mark Slick).

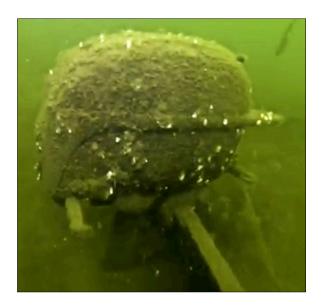
Left: The wreck's motor (by Kelly Nehowig).

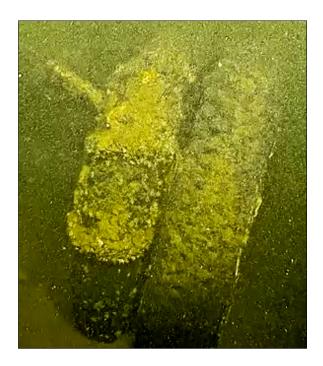
Above: The right rear tires are intact, with chains around the inner wheel (by Mark Slick).

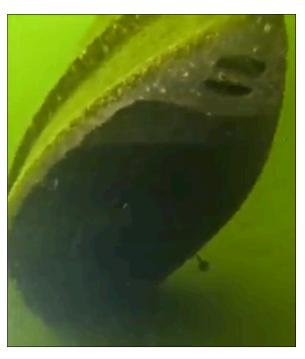
The wreck suspended in the water column (by Kelly Nehowig).

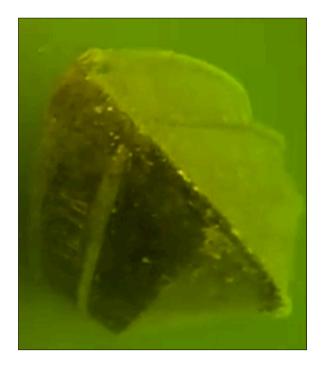
The wreck's bow (by Kelly Nehowig).

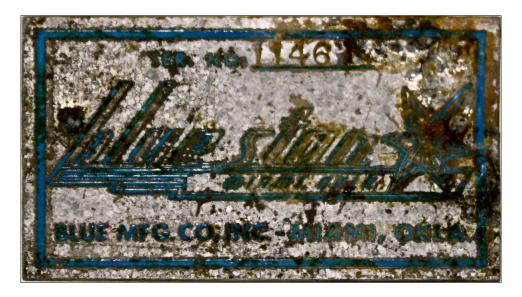
The builder's plate was removed and then returned to the Blue Star Miamian Custom Runabout Wreck (Anomaly 31). If MHM had not located and cleaned this plate, the identity of the wreck would still be unknown (by MHM).

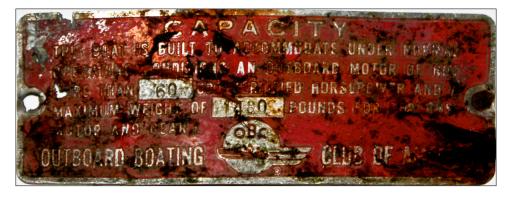
This Outboard Boating Club of America capacity and ratings plate assisted MHM in determining that Anomaly 31 is a Miamian Custom Runabout due to the maximum weight and horsepower engine she could carry (by MHM).

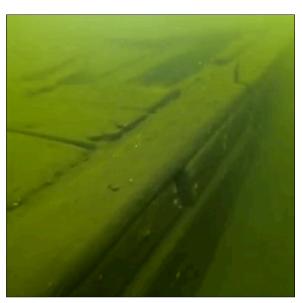
Left: The amidships deck and hull of the wreck (by Kelly Nehowig).

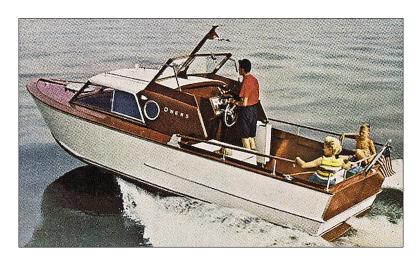
A smooth-hulled 1959 Owens Cruiser Deluxe (Holiday 1959, 112-113).
